## Application Note No. 008

# Cause analysis of DC wiring failure

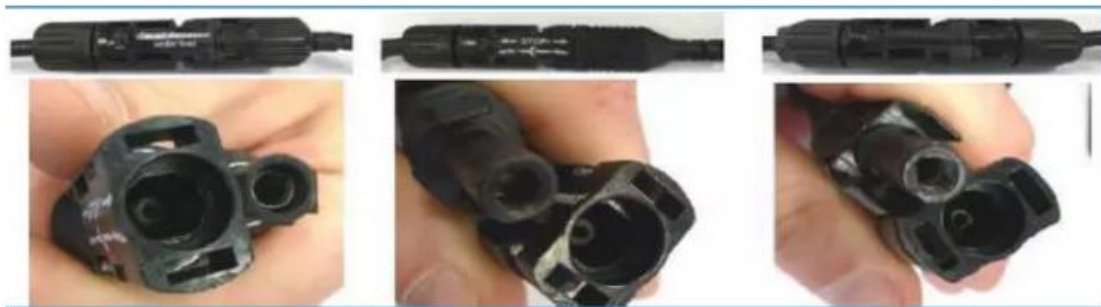
### 1. DC Connectors of different brands are plugged into each other

Although different brands of DC connectors look similar in appearance, they can also be connected each other during installation. However, but due to the inconsistencies in the specifications of the external packaging of different terminals, the specifications of internal conductors, dimensions and tolerances; if two different brands of terminals are mixed to be used, it will cause the contact resistance of the connector increases, the temperature increases, and the IP rating decreases during the inverter running; and meantime heat generation and the decrease of insulation resistance will directly cause the temperature of the connector to rise during inverter running, accelerate the aging of the plastic and even catch fire.

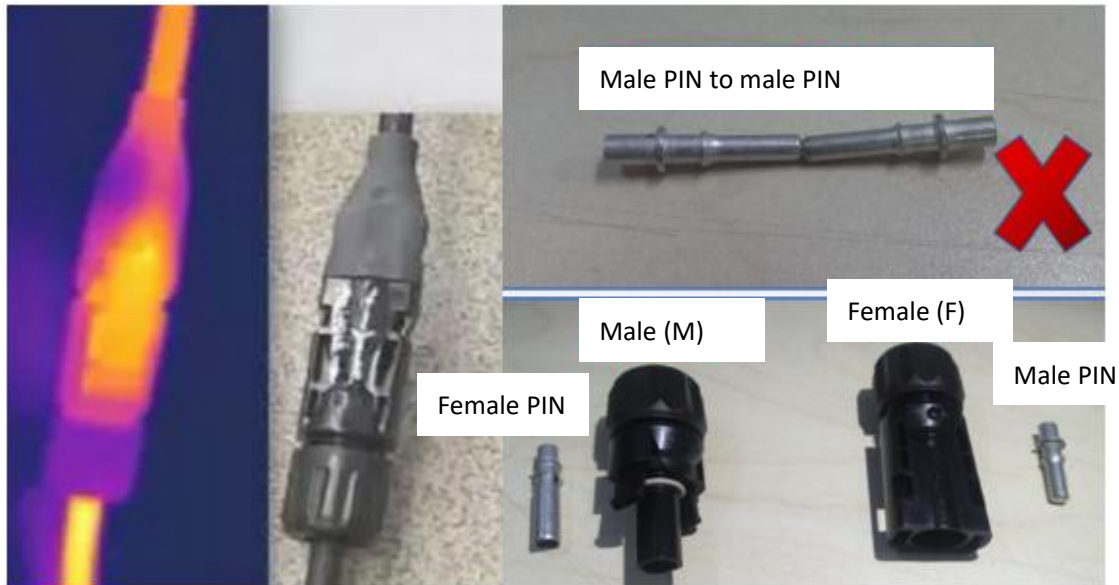
### 2. Terminal core does not match

In the male and female heads of the MC4 DC connector, there is no matching terminal core (that is, the male and female heads are both same type pins), resulting in unreliable connection in the DC connector, and the contact resistance is very large. The core heat increased significantly and burned the terminals.

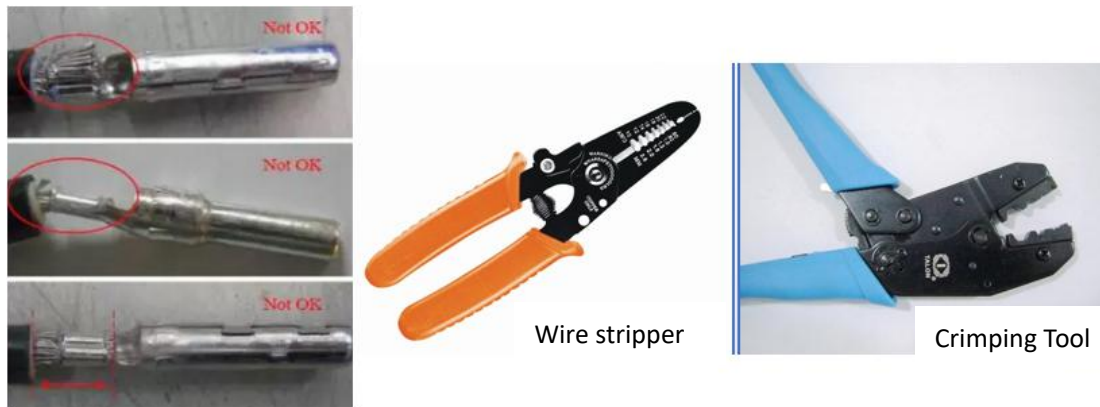
### 3. Irregular crimp

Poor crimp quality of connectors is another common problem. Due to the difference between the tools used on site and the operating experience, the crimping quality is poor. The most common situation is that the cable copper wire is bent, part of the copper wire is not crimped in, and the crimped part is the cable insulation layer.

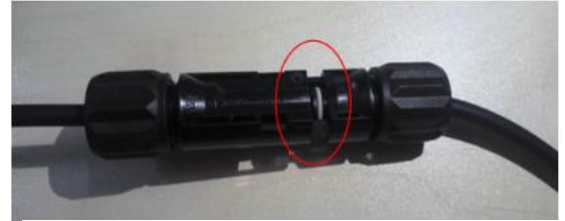
When the male connector and the female connector are connected, if the installer does not hear a "click" sound, it means that the male connector and the female connector are not reliably connected. This will lead to the following situations:

a) The string is open, no current is input into the inverter in the string, and the utilization rate of the PV module is low, resulting in low power generation efficiency of the system;

The terminals are not connected tightly

b) The contact resistance is very large, and there is a significant heating effect after passing the current, and the temperature rise causes the terminal to burn out;

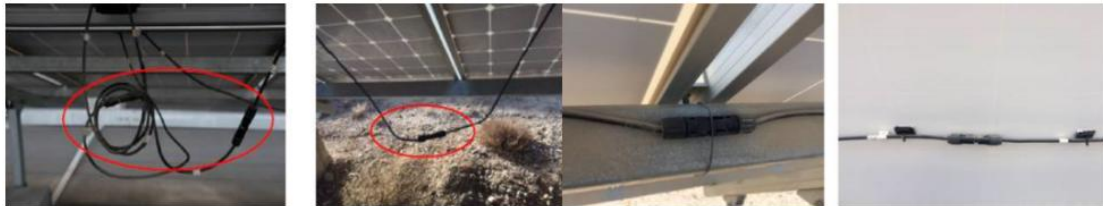
## 5. DC Connector floating

The connector is suspended in the air for a long time, and it shakes due to the influence of wind, which may cause damage to the shell. If the early plug connection is not tight, it is easy to disconnect and fall off. The common solution is to fix the connector on the bracket or component backplane.

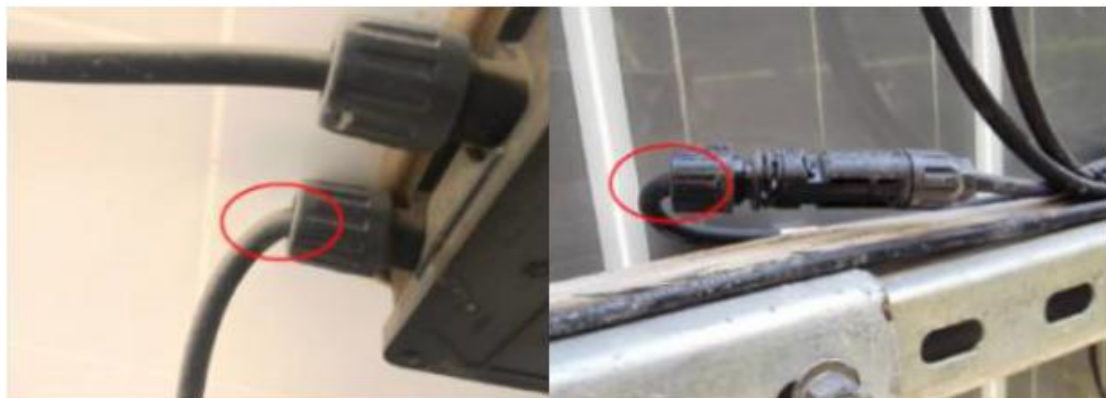
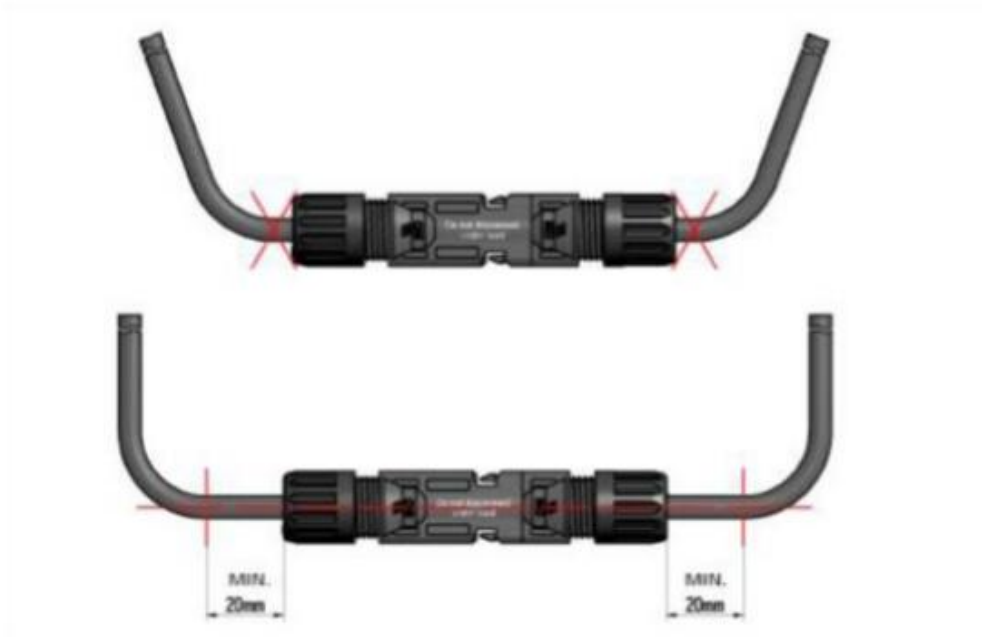
## 6. Wiring

Irregular wiring will cause a large force between the connector and the cable, which may easily cause breakage or seal failure during long-term operation. The common solution is to lengthen the wiring slightly to ensure that the 20 mm cable from the cable seal is not bent or compressed.
